EXPERIMENTAL STUDY OF OPEN WEB STEEL JOISTS WITH CRIMPED CRITICAL WEB MEMBERS

E.T.Buckley¹, D.W.Dinehart², P.S.Green³, S.P.Gross², J.R.Yost²

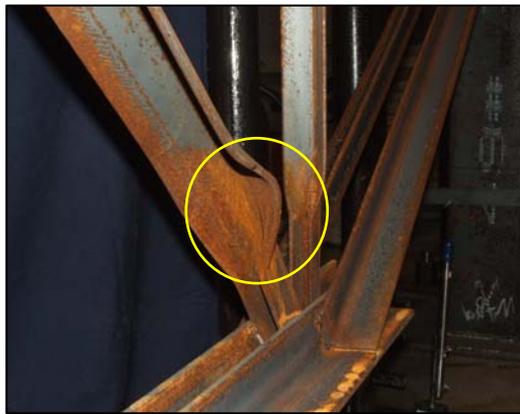
Figure 1 Buckling of the crimp transition zone (J2250-R2)

Buckling of the crimp transition zone is a local buckling failure that occurs when the transition zone bulges and the web member can no longer maintain its capacity. The transition zone can be defined as the location where the web member changes from its crimped shape to its natural angle shape. Table 5 shows a breakdown, in terms of joist type and manufacturer, of the eighteen joists that failed at the crimp transition zone.

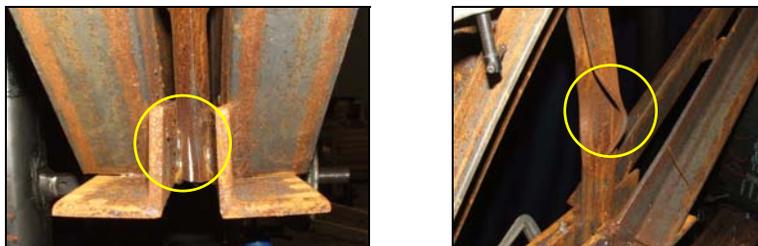
Figure 2 Buckling of crimp transition zone and member fracture (J2200-R1)

The next failure type to be discussed includes a buckling of the crimp transition zone in addition to a failure of the weld or a fracture at the end of the critical web member. Table 6 shows a breakdown, in terms of joist type and manufacturer, of the seven joists that failed due to member fracture and buckling at the crimp transition zone.

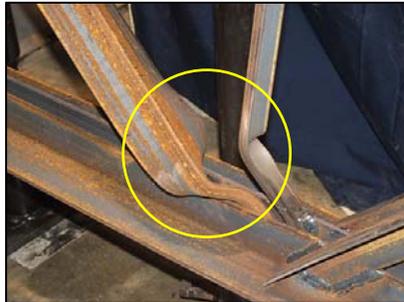
Figure 3 Out of plane buckling at the crimp (J3250-W1)

The third failure type is out of plane buckling of the critical web member's crimped section. This type of failure occurs when the crimped section of the web member buckles at the chord connection in its weak direction, out of the plane of the joist. Table 7 shows a breakdown, in terms of joist type and manufacturer, of the eight joists that failed due to buckling of the crimp.

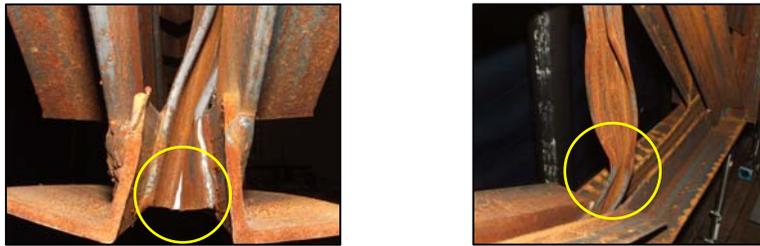
Figure 4 Out of plane buckling at crimp and member fracture (J1200-W1)

The fourth failure mode is out of plane buckling of the crimp in addition to a weld failure or fracture at the end of the critical web member. Table 8 shows a breakdown, in terms of joist type and manufacturer, of the seven joists that failed due to member fracture and buckling of the crimp.

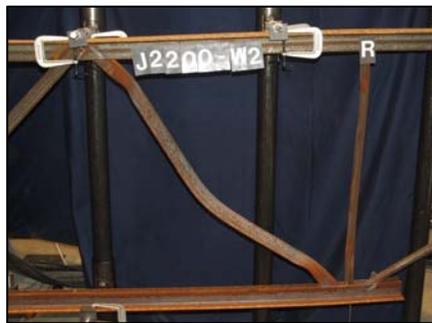
Figure 5 In-plane buckling of the uncrimped section (J2200-W2)

The fifth critical web member failure mode is buckling of the uncrimped section in the plane of the joist. This is a flexural buckling failure of the entire critical web member. The uncrimped section can be defined as the portion of the web member, between the two transition zones, where the angle has returned to its natural shape. Table 9 shows a breakdown, in terms of joist type and manufacturer, of the seven joists that failed due to flexural buckling of the uncrimped section.

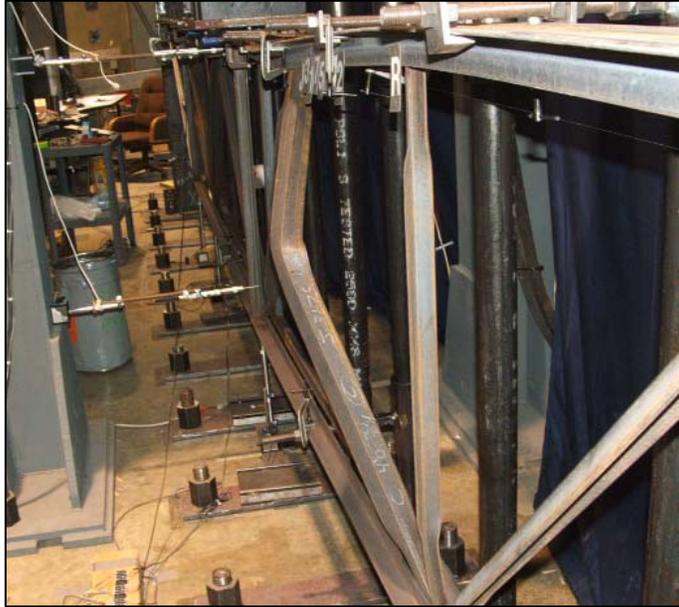
Figure 6 Out of plane buckling of the uncrimped section (J3175-W2)

The next failure mechanism is out of plane buckling at the critical web member’s uncrimped section. This failure mode is identical to the previous one, with the only difference being the direction the buckling occurs in. Table 10 shows a breakdown, in terms of joist type and

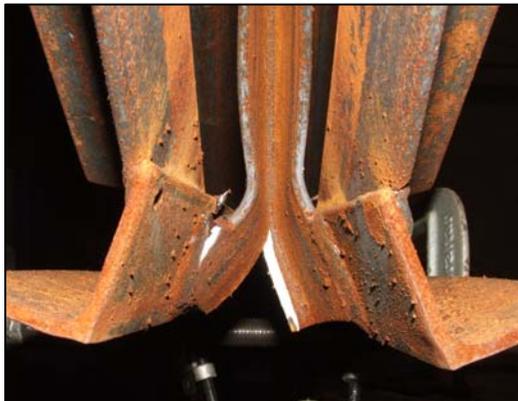
Figure 7 Weld and member fracture at the chord connection (J1175-W1)

The seventh and final critical web member failure mode is weld failure or member fracture at the bottom chord connection. This type of failure is the only non buckling mechanism that the critical web members failed in. Table 11 shows a breakdown, in terms of joist type and manufacturer, of the five joists that failed due to weld and member fracture at the bottom chord connection.

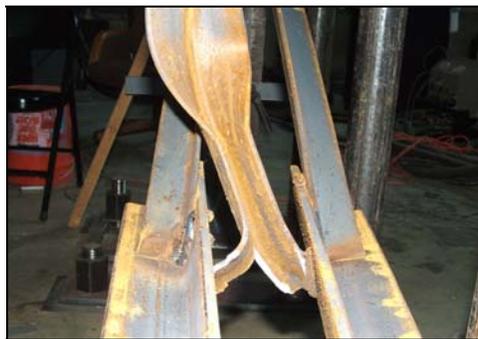
During this testing program, there were twenty-three failures that occurred due to some form of web member fracture at the bottom chord connection. Each of these failures occurred where a crimped member was sharing a joint with an exterior tension web. All twenty-three of these failures occurred when the exterior web member was constructed as double angles welded to the outside of the bottom chord angles. The other type of member used at this location is a solid round bar welded to the interior of both bottom chord angles. A photograph of this type of failure can be seen in Figure 12.

Figure 12 Fracture of Web Member at Bottom Chord Connection
